P1157, P0134 and LAF Sensor Replacement

At 322K miles my 2007 4CYL Accord SE had a CEL experienced the following codes:

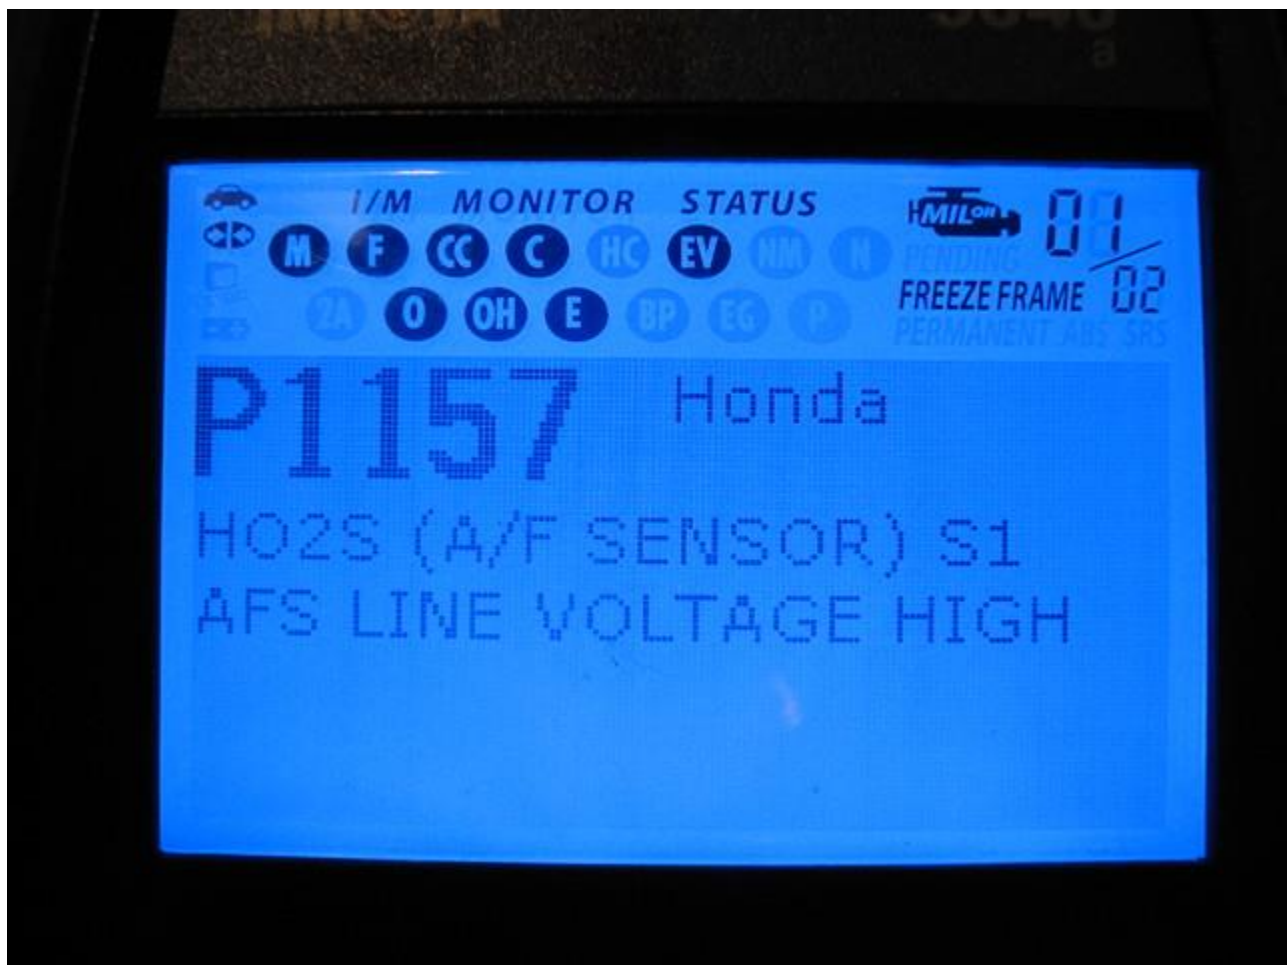
I began by clearing the codes and P1157 immediately came back (but not P0134).

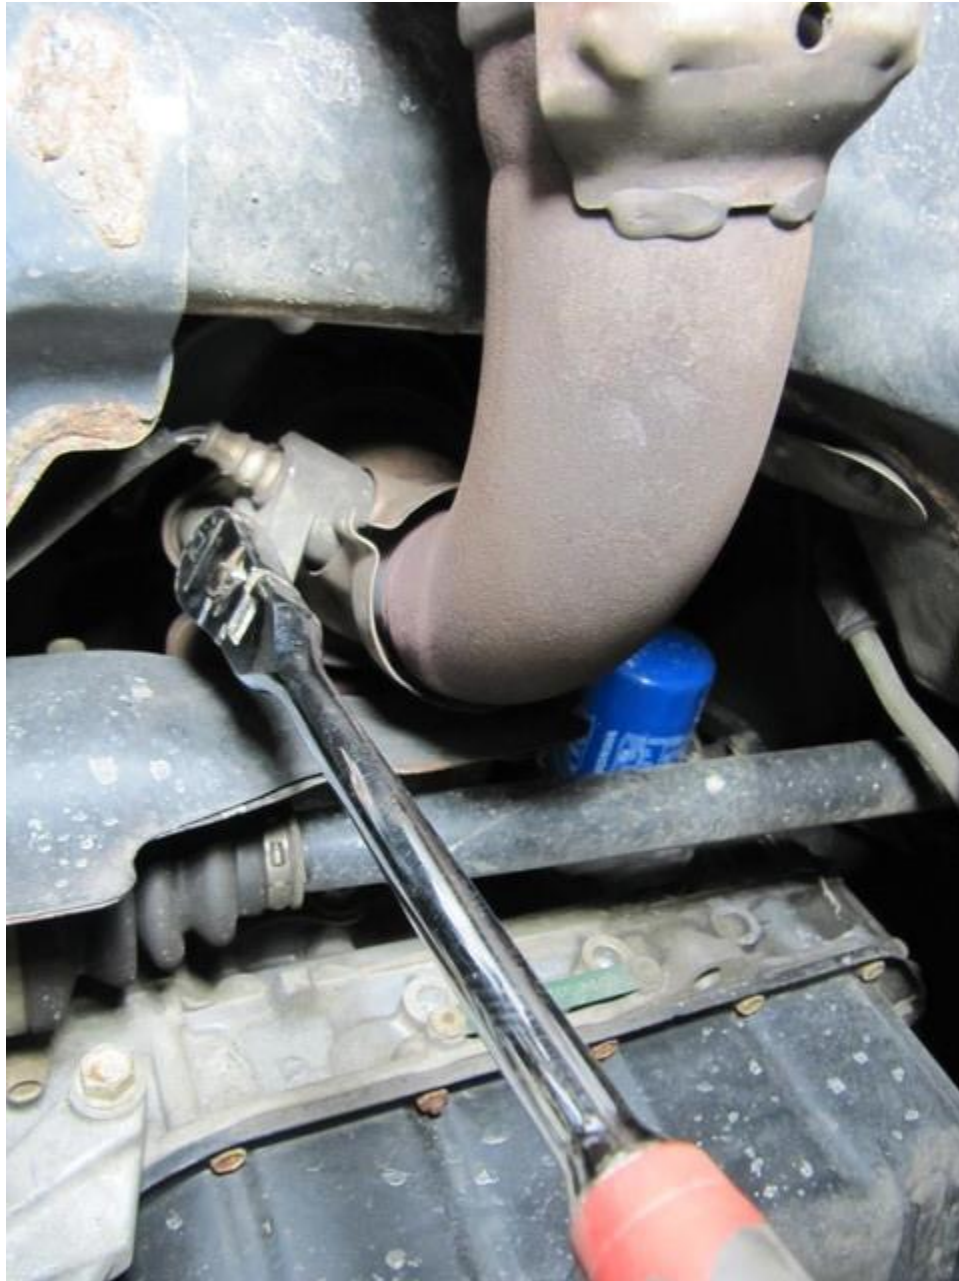
The air/fuel sensor is located in the exhaust pipe at the back of the engine. I used an oxygen sensor socket to remove it:

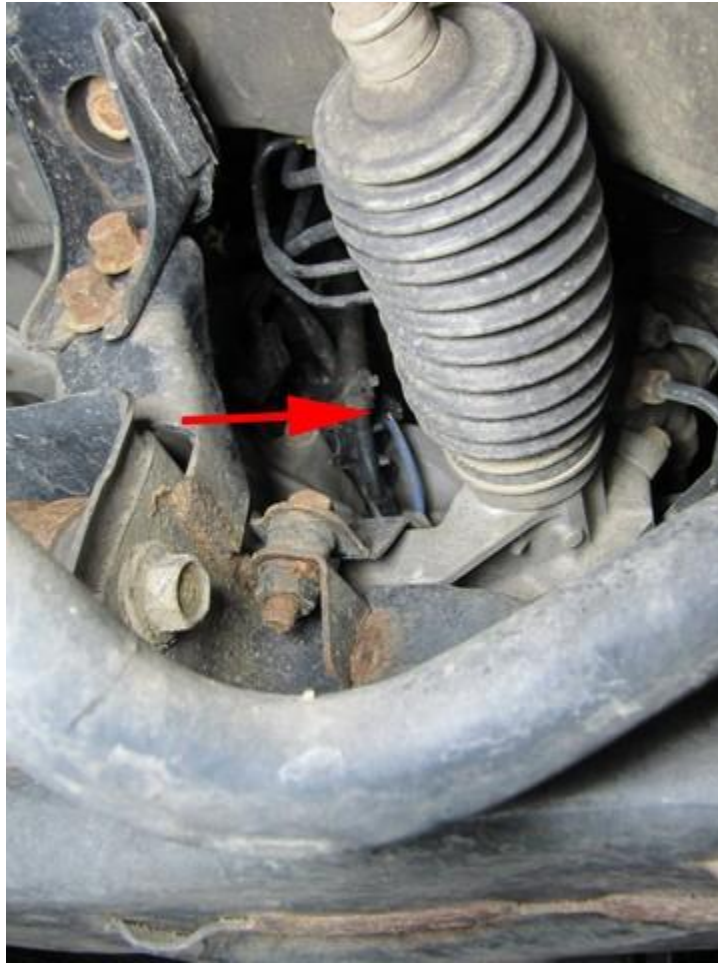
The oxygen sensor connector can be seen looking in the driver side wheel well:

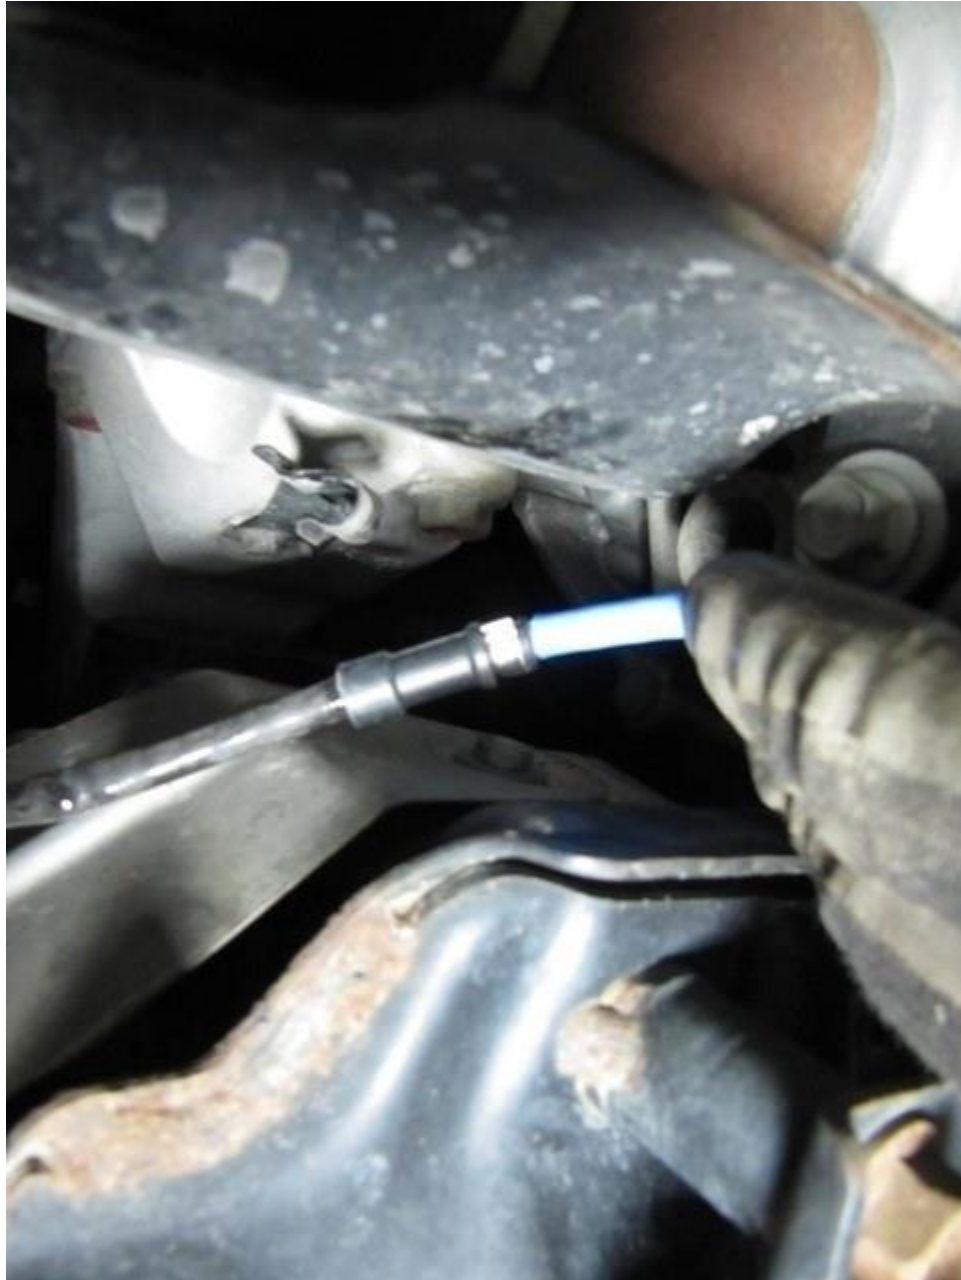
There is also a wire holder that supports the LAF sensor wire:

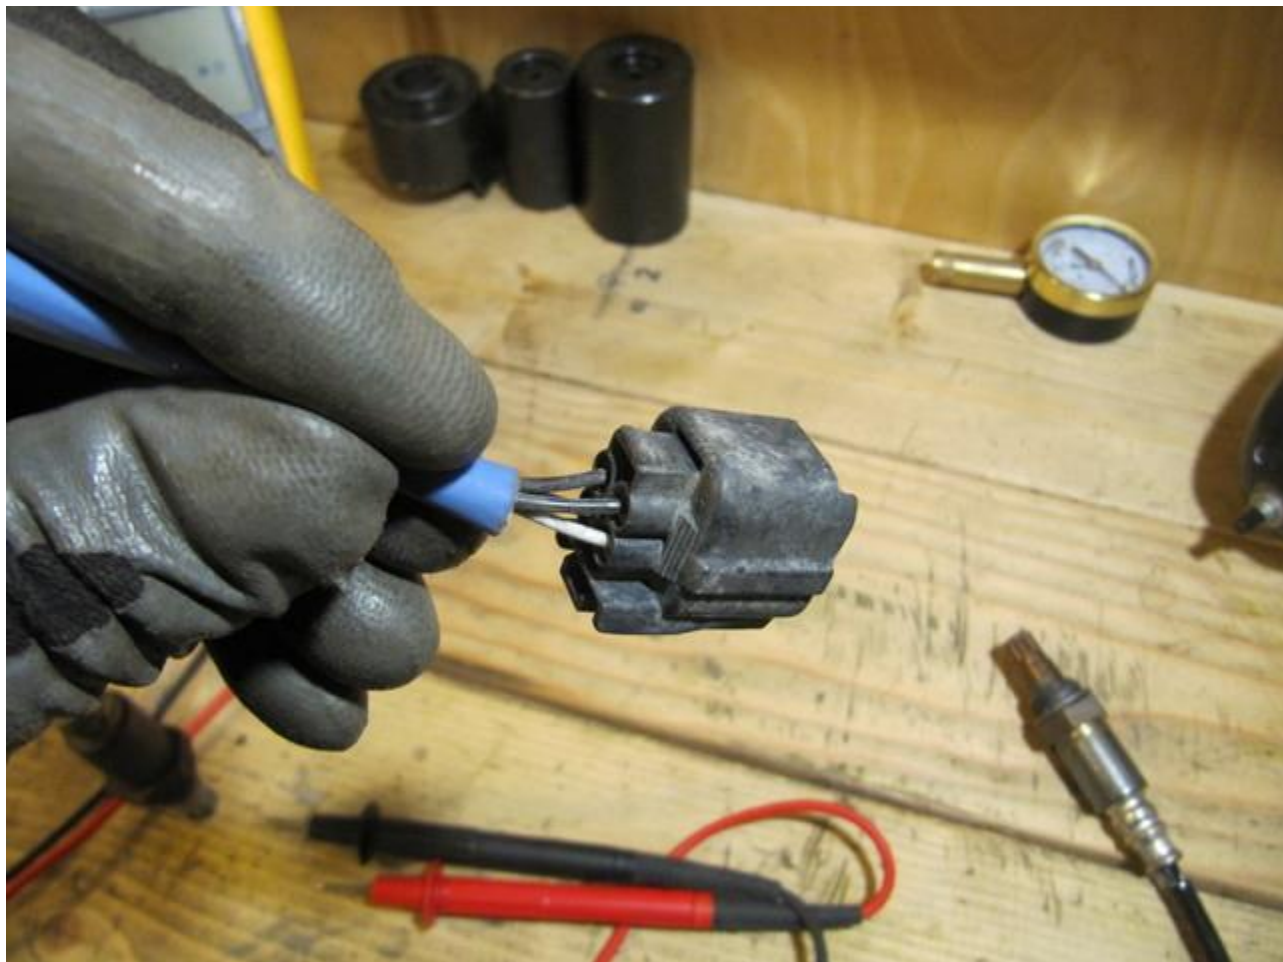
You can check the condition of the heater element by measuring the resistance between the black wires. The resistance should be between 2.1 and 2.9 Ohms at room temperature:

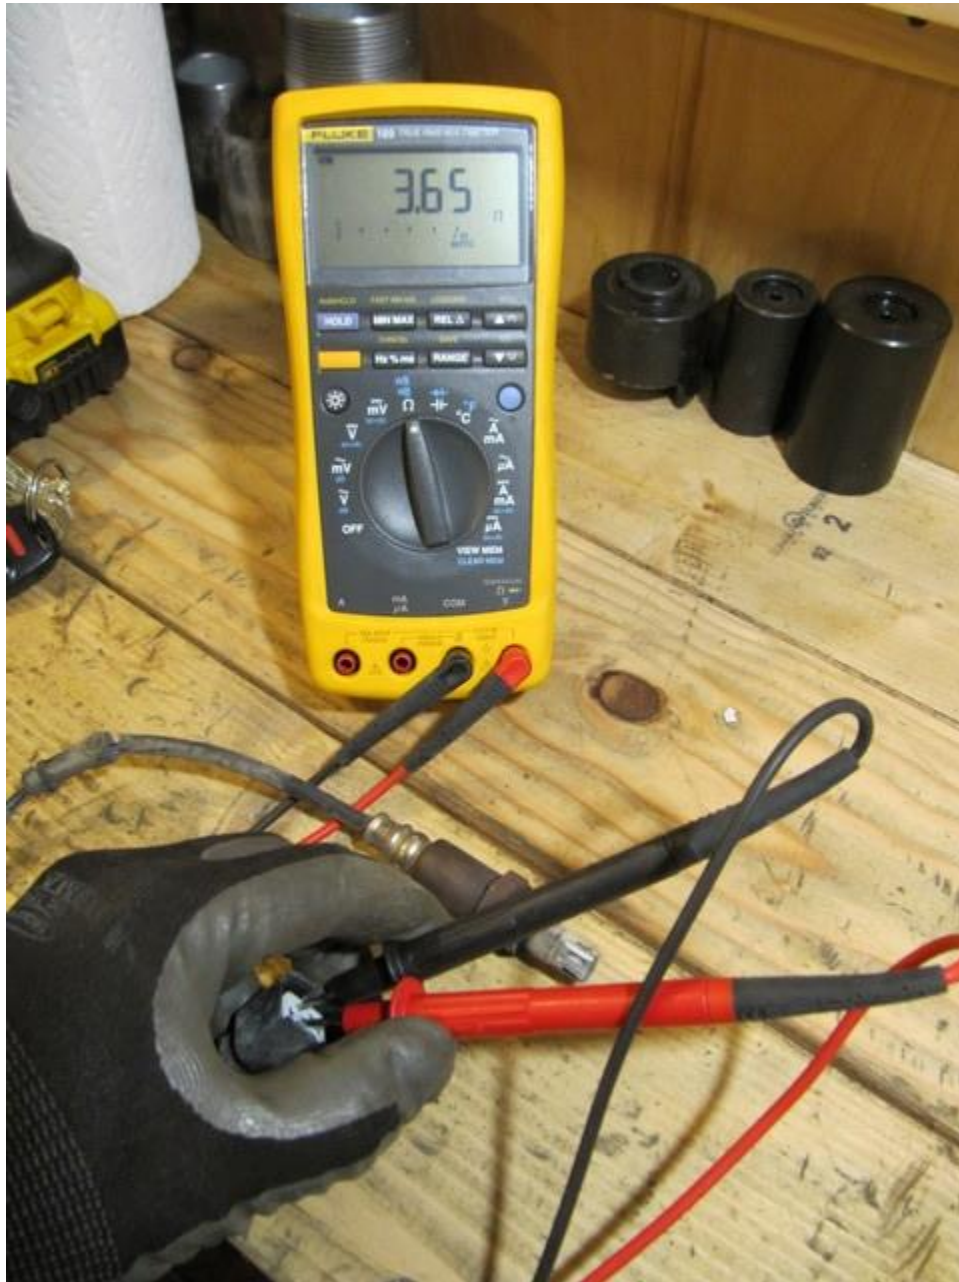
My old (bad) air fuel sensor measured 3.65 Ohms (OUT OF SPEC - High):

This was still the original air/fuel sensor (with 322K miles on it) so I decided to replace it based on the code.

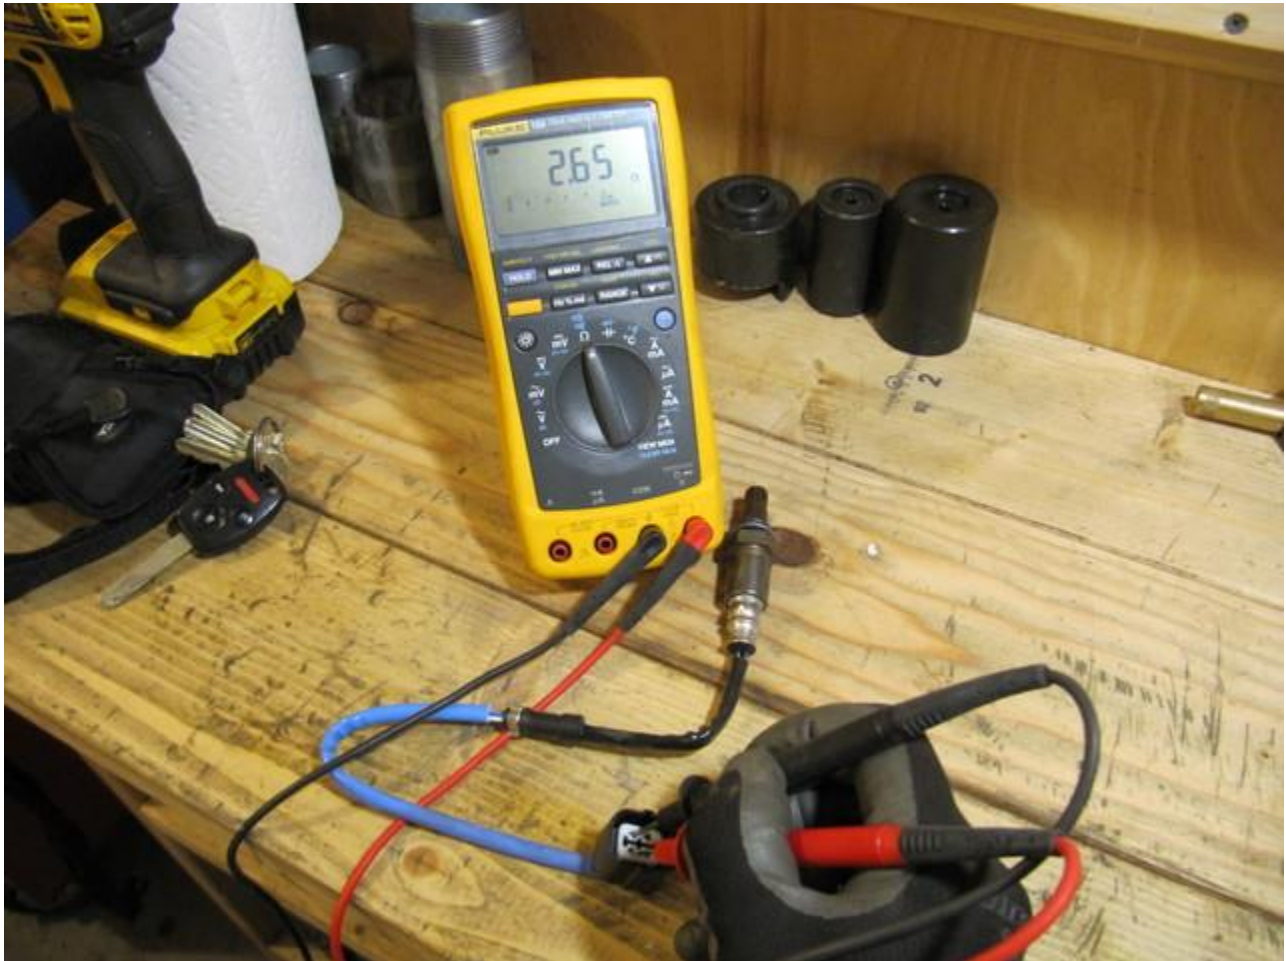
The new air/fuel sensor measured 2.65 Ohms (IN SPEC):

Replacing the air/fuel sensor successfully eliminated the CEL and trouble codes.
